Tank-Car Thermal Protection Defect Assessment: Updated Thermal Modelling with Results of Fire Testing

SUMMARY REPORT

Transportation Development Centre
of
Transport Canada

A.M. Birk Engineering
Kingston, Ontario, Canada

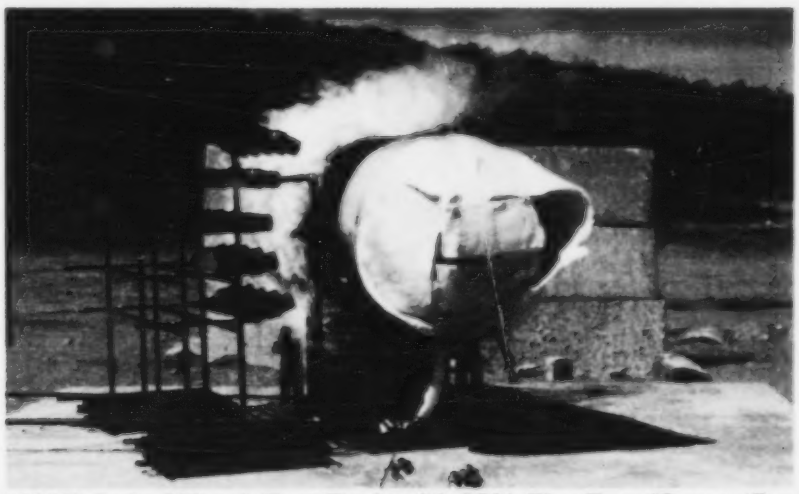
Figure 4: ASME Code 500 gal. Test Tank with 25% Fire Engulfment (fire blackbody temperature 800-900°C) [4]

These tanks were 25 percent engulfed in fire. The fire blackbody temperature was in the range of 800 to 900°C, which is in the range of credible hydrocarbon pool fires. Three cases are presented here – a baseline test with an unprotected tank (no insulation or jacket) and then 15 percent (large defect) and 8 percent defect cases. The tanks were protected with new tank-car insulation (13 mm ceramic blanket) and this was covered with a 3 mm steel jacket in the area covered by fire.

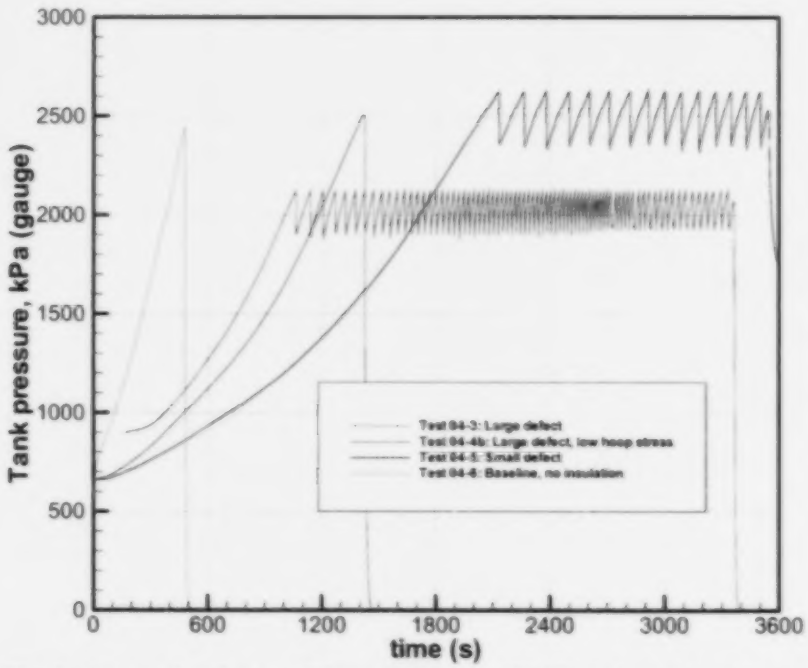
Figure 5: Tank Pressurization vs. Time (500 gal. ASME code tank with various levels of thermal protection, tank 25% engulfed in fire) [4]

Figure 5 shows how thermal protection affects the tank pressurization rate. The tank with the best thermal protection (8 percent defect) pressurized the slowest. Figure 6 shows how the wall temperatures rise in the defective areas. Note that the tanks failed where the plots end. None of the tanks with simulated defects failed catastrophically, but rather they failed with axial fissures of differing lengths. The smallest defect had the smallest rupture length.

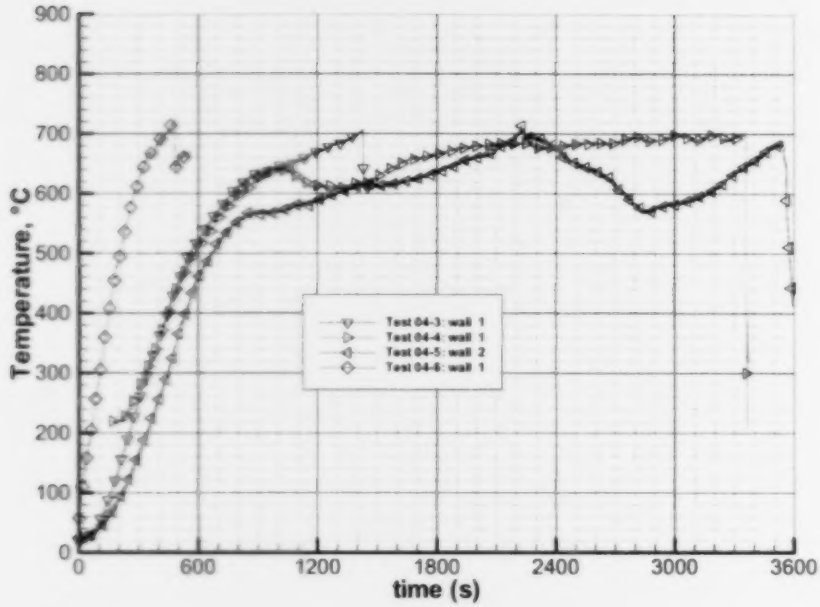
Figure 6: Measured Peak Wall Temperature in Defect vs. Time (500 gal. ASME code tank with various levels of thermal protection, tank 25% engulfed in fire) [4]

As can be seen, the defective cases reach the same peak wall temperatures as the unprotected cases, but it takes longer to achieve these temperatures. It should be noted that the wall temperatures were affected by wind moving the fire. Where there is a sudden drop in the wall temperature, this means the wind decreased the fire heating. One needs to extrapolate in the graph to get the time to failure without wind effects. It can be seen that the tanks all failed when the wall temperature exceeded about 710°C. If we consider the small defect case, the tank failed at 59 minutes. However, if the wind had not reduced the fire effect, it is very likely the tank would have failed at about 36 minutes.

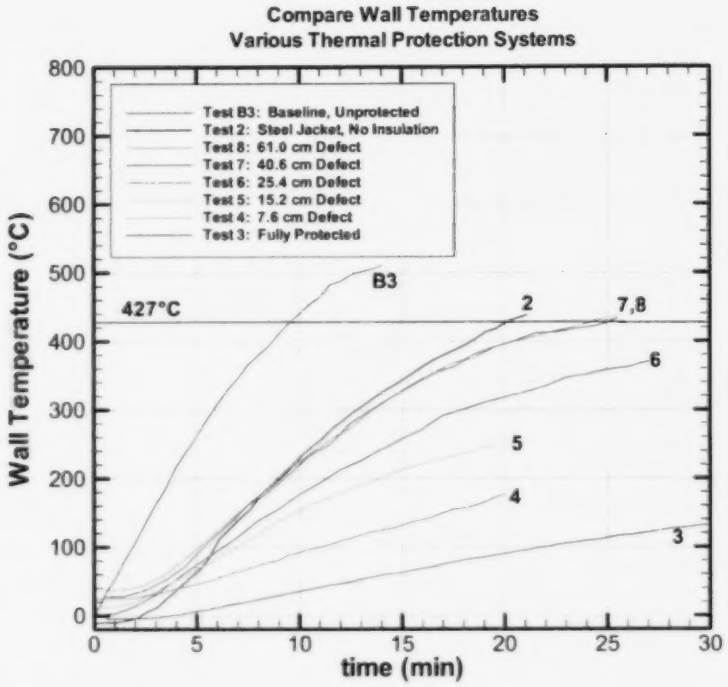
Figure 7: Measured Peak Temperatures Under Thermal Protection Defects (16 mm plate) Heated by Engulfing Fire (effective blackbody T = 840°C) [16]

Heat transfer modelling [6] and fire testing [16] have shown that the critical defect size, from the standpoint of heat transfer, for a 16 mm thick plate is about 0.4 m x 0.4 m. At this size the centre of the defect area is not significantly cooled by the surrounding protected and cool metal. In other words, the centre of this plate will heat up as if it were not surrounded by protected material. This is shown in Figure 7 from [16].

As can be seen from Figure 7, a defect 0.4 m square (test 7) is about the same as a 100 percent defect case (test 2).

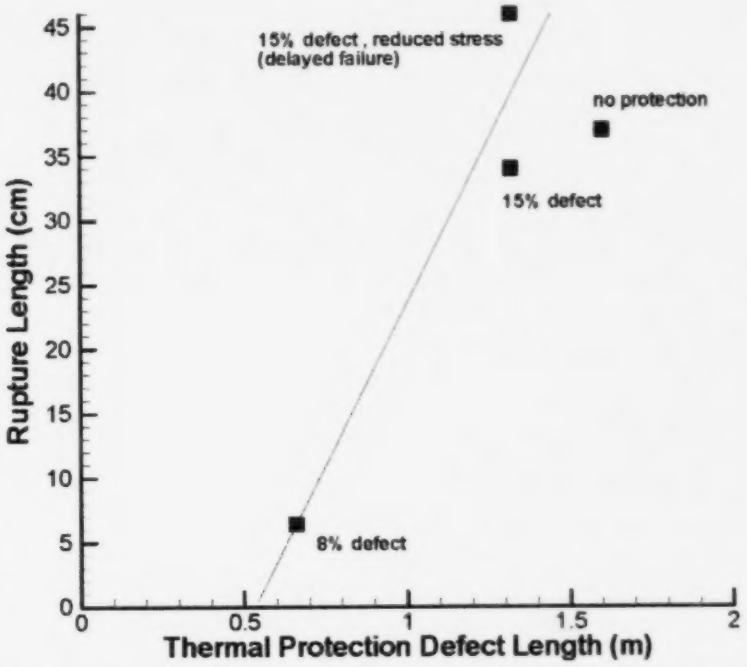
Figure 8: Rupture Length vs. Thermal Protection Defect Length (500 gal. tank, D = 0.96 m, 7.1 mm wall, SA 455 steel, fire heated length about 1.6 m, data from [4])

The length of the resulting ruptures depended on the length (along the tank axis) of the thermal protection defect. Figure 8 shows how the rupture length varied with the thermal protection defect length. If we linearly extrapolate this data to zero rupture length (pin hole) then the resulting thermal protection defect length is about 0.55 m for the 500 gal. tank. This was for a 7.1 mm thick wall. If we scale this size based on the plate thickness, then the defect must be about 1.2 m long for a 112J tank-car with a 16 mm thick wall.

Therefore, theoretically, a defect only needs to be about 1.2 m long (along tank axis) by about 0.4 m wide to result in a small fissure on a 112J type tank-car. As it turns out, the blanket width of typical thermal insulation rolls is 1.2 m. Such a failure would probably not result in a catastrophic failure of the tank – but it could. The small fissure would probably act like an additional pressure relief device. However, small cracks can propagate to completely open the tank if the conditions are right. It is difficult to predict this with certainty and therefore any rupture should be considered unacceptable.

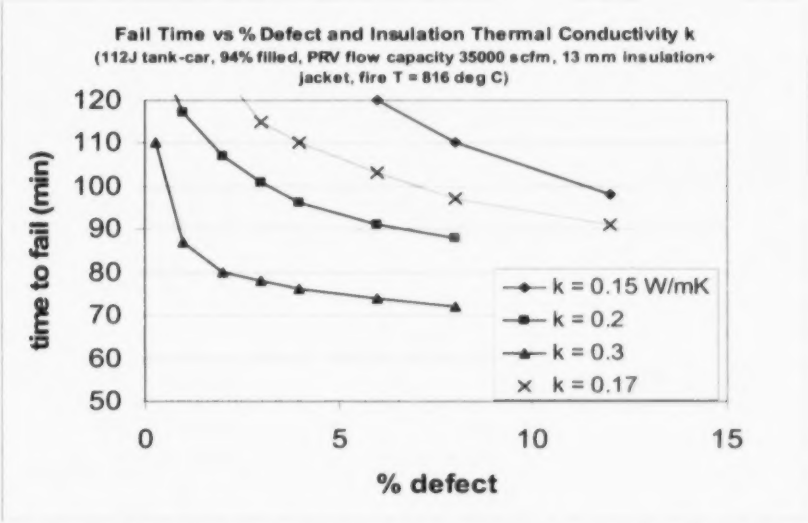
Figure 10: Predicted Time to Failure vs. % Defect and Overall Effective Thermal Conductivity of Thermal Protection System (assumes 13 mm ceramic blanket)

As can be seen from Table 6, it only takes about 4 percent of the surface to be defective of insulation for the tank to fail within the 100 minute time frame when k = 0.2 W/mK. This requires that there be at least one large defect near the top of the tank.

A set of simulations was preformed for a range of defect areas and k values. These are summarized in Figure10. As can be seen from the figure, the allowable defect depends strongly on the effective conductance of the overall thermal protection system. We do not have any good data for this from the existing tank-car fleet. Testing is necessary to establish this.
